August 1966

Development Report

B-52/KC-135 COLLISION

NEAR PALOMARES, SPAIN (U)

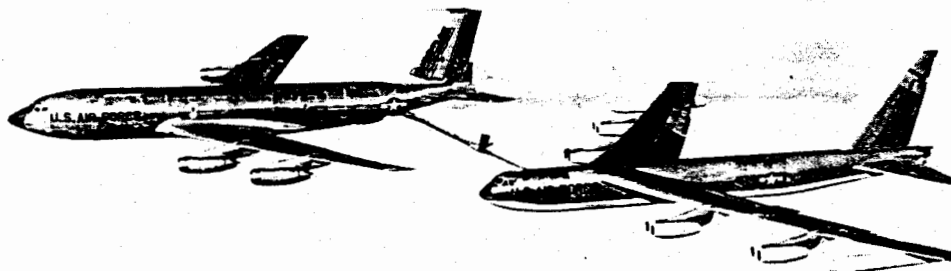
Figure 1. KC-135/B-52 Mid-Air Refueling

On January 17, 1966, a B-52G aircraft carrying four Mk 28FI(Y1) weapons in an MHU-20/C clip-in assembly (Figures 1 and 2) collided with a KC-135 tanker in the vicinity of the village of Palomares on the southeast coast of Spain (Figure 3). The accident occurred at 10:25 AM, local time, in good weather. The accident happened during a routine refueling of two airborne alert (Chrome Dome) B-52G aircraft from Seymour Johnson AFB, North Carolina, by two KC-135 tankers from Moron AFB, near Sevilla, Spain.

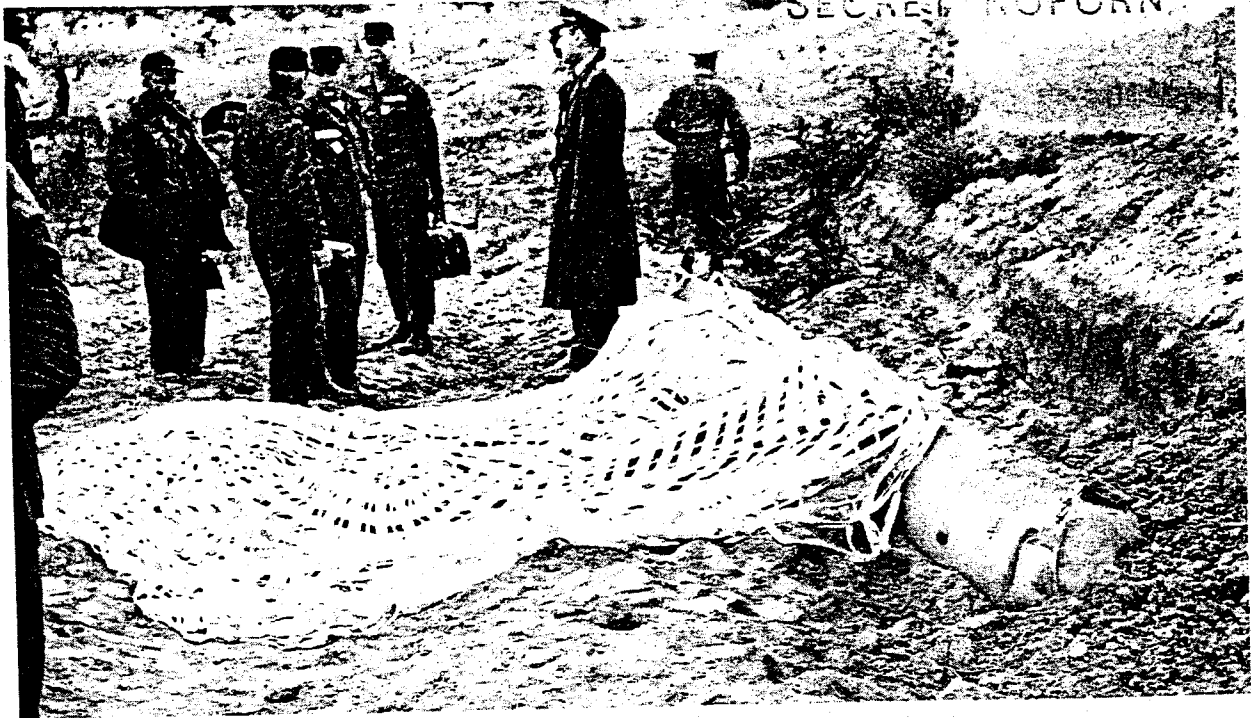
Figure 5. Weapon #1

Weapon #1 (Left upper position in clip-in assembly) -- The weapon was in relatively intact condition, having been retarded by abnormal deployment of the 16-1/2 foot parachute and impacting on a steep bank of soft earth. The nose section of the fuze was crushed and dented and the afterbody (shape component) suffered a few dents. The tail plate and three fins were missing. The MB-3A

rack was attached to the weapon lugs, and two pieces of the MHU-20/C clip-in assembly were attached to the rack. One pullout rod had been extracted.

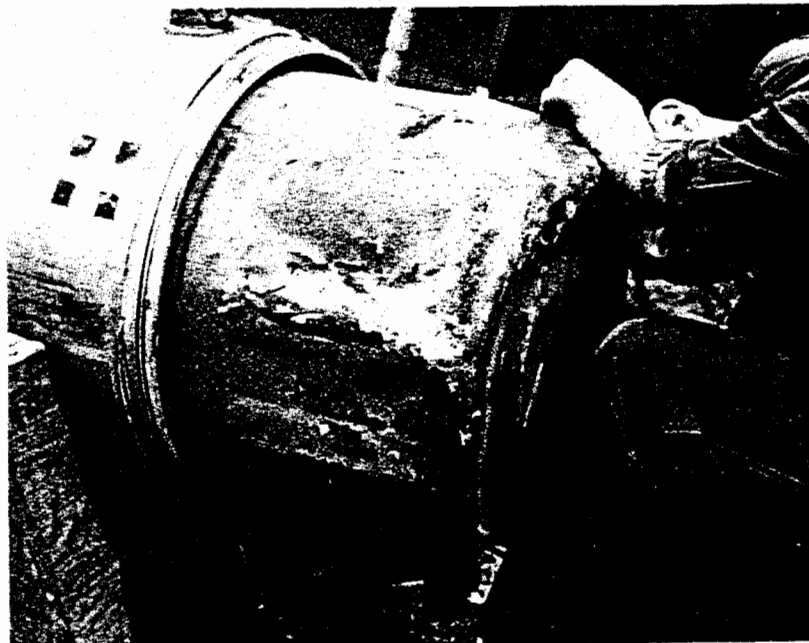
Figure 33. Weapon #4, Crushed Warhead Pressure Cover

The weapon was subjected to two principal sources of damage: the forces during aircraft breakup and the water pressure at the considerable depth.

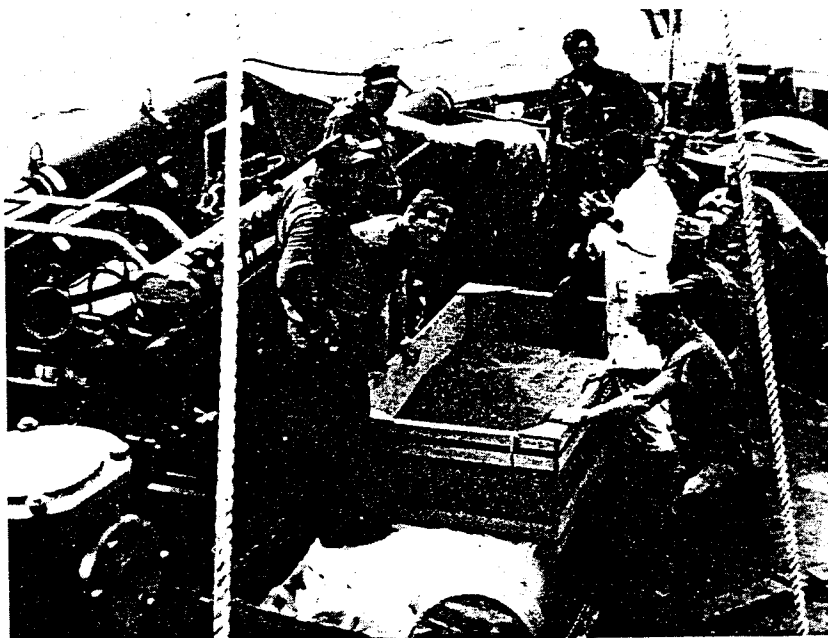
Figure 42. Weapon #4 Warhead Being Covered with Sand

it by removing the inner engine support frame, by cutting holes in the cover for ventilation, and by building an inner box to permit covering of the warhead portion with sand. This container and 16 drums of beach sand were loaded aboard the USS Hoist which was the recovery vessel designated at that time. Two EOD sergeants from the 16th Air Force accompanied the material.

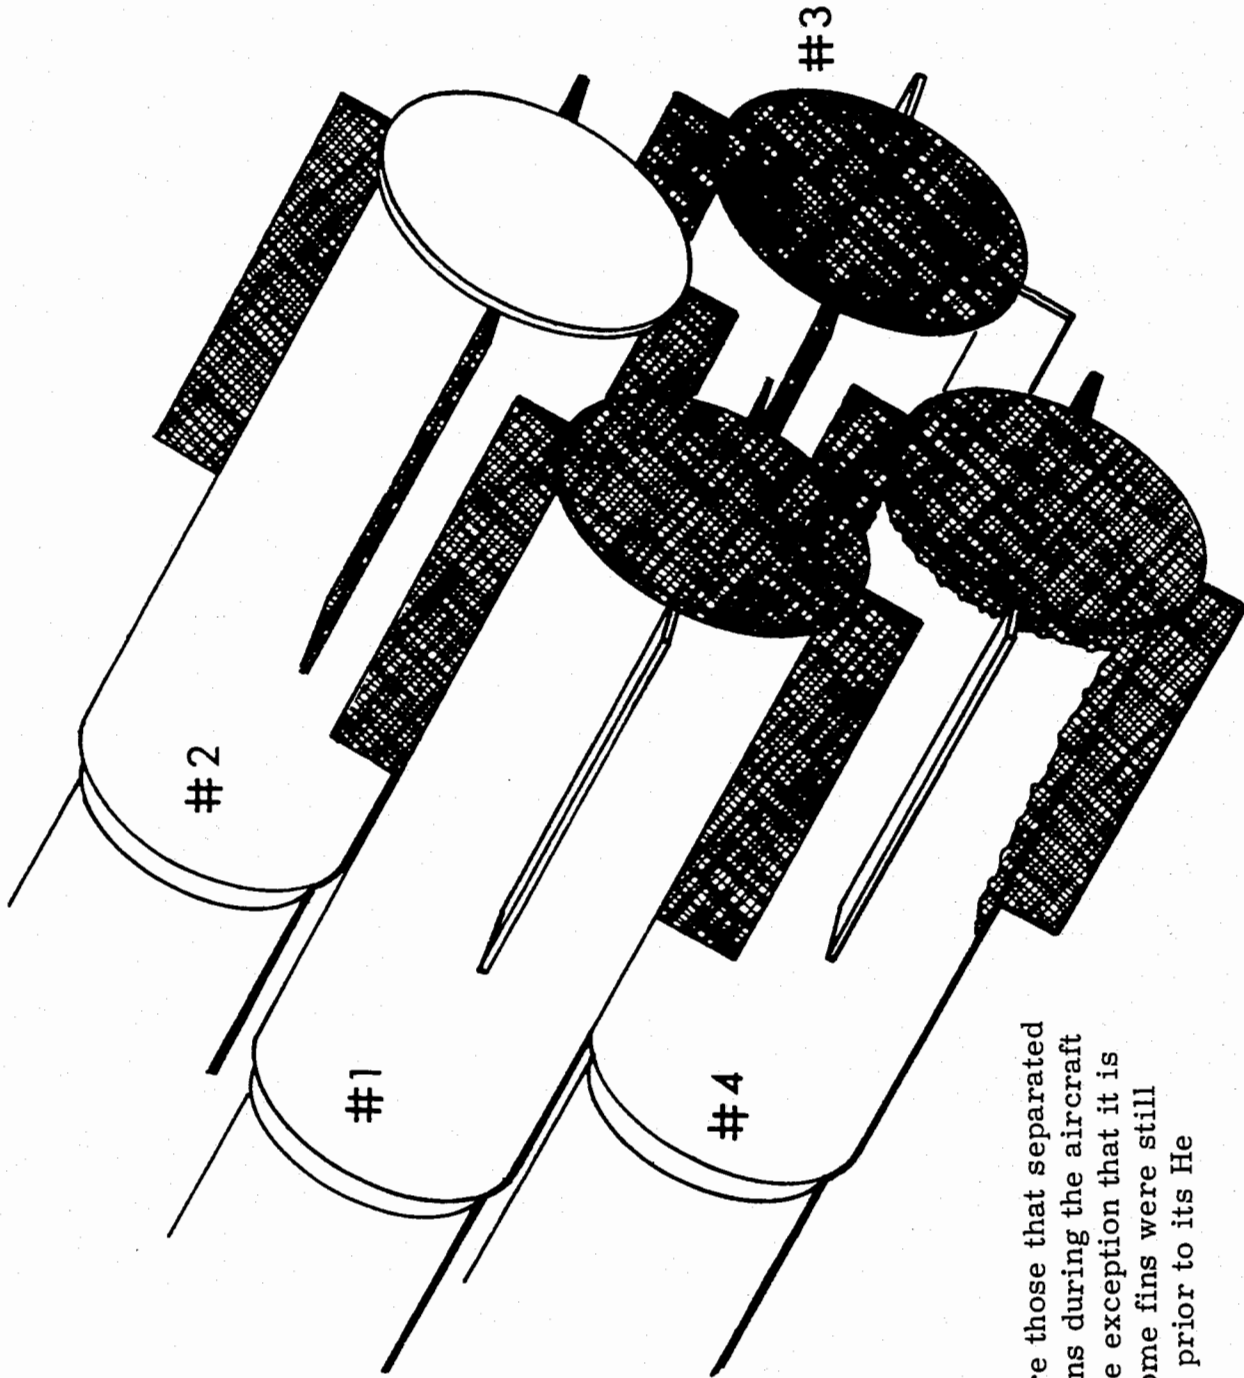
Figure 44. Weapon Damage at Aircraft Breakup

16-1/2-foot and 64-foot parachutes in one other weapon (Figures 44 and 45). An analysis of the parachute operation is presented in Appendix C.

Note: Shaded parts are those that separated from the weapons during the aircraft breakup with the exception that it is possible that some fins were still with Weapon #2 prior to its He detonation.

*Note: Three fins were found between the crash - and afterburner debris (was close to the debris) by Capt Goodenham as disclosed 3-2-67*

On weapons #1 and #3, the tail plates were torn off by forces apparently being applied at the edges that overlap the afterbody proper. This resulted in near normal deployment of the 16.5-foot chutes, although the chute in #3 weapon was apparently torn in the process.

Weapon #4 was damaged in a different manner; the afterbody was subjected to a crushing action in the area of one fin which resulted in (1) the splitting of the afterbody case section and (2) the apparently progressive failure of rivets connecting the afterbody skin section to the rear ring forging and subsequent separation of the rear ring forging and cover plate from the weapon. Again, this resulted in deployment of the 16.5-foot chute; but, in addition, the afterbody damage resulted in abnormal removal of the bag from the 64-foot parachute, which permitted its subsequent deployment. Since the 16.5-foot chute shroud lines were still attached by loops to the spider, the weapon descended with both chutes deployed.
